Manhole Inspection Summary

Manhole # S09CC2001MH

Insp Date: 11/1/06 1:07 PM

Location Address: **5801 RUSK AVE**

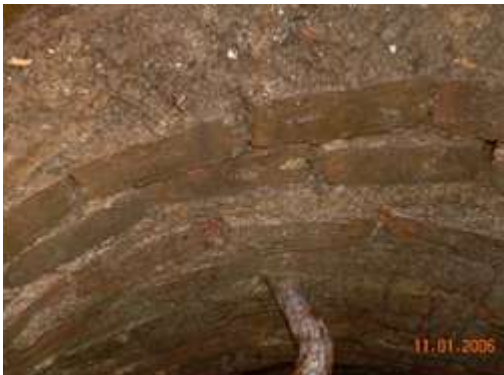
Defect

Offset: **2** (in.)

Infiltration: ☐ None ☒ **Joint** ☐ Cracks ☒ **Mortar** ☐ Roots ☒ **Wall**

Infiltration: ☐ None ☐ Joint ☐ Cracks ☒ **Mortar** ☐ Roots ☒ **Wall**

Frame offset. Adjustment and Corbel infiltration.

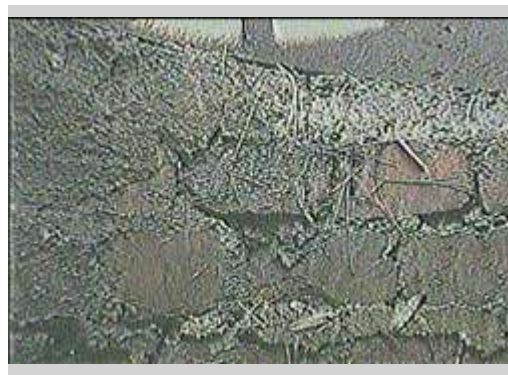
Defect

Adjustment infiltration.

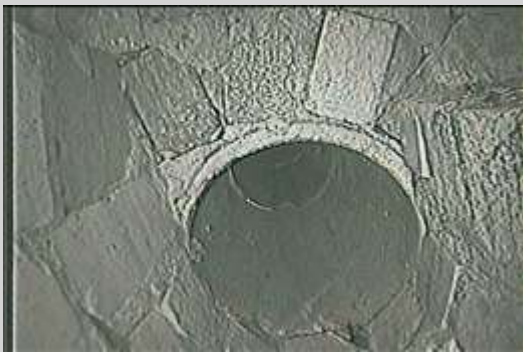
Pipe Out @ 12 O'Clock

Infiltration: **Evidence** Pipe Seal Cond: **Cracked**

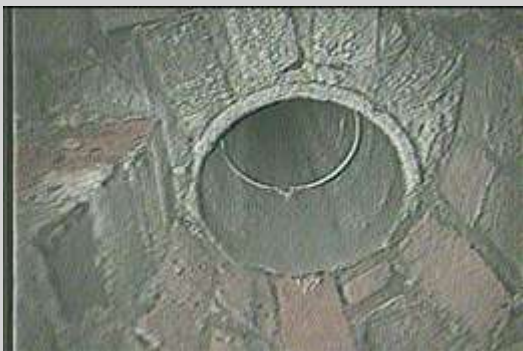
Pipe In @ 4 O'Clock

Infiltration: **Evidence** Pipe Seal Cond: **Cracked**

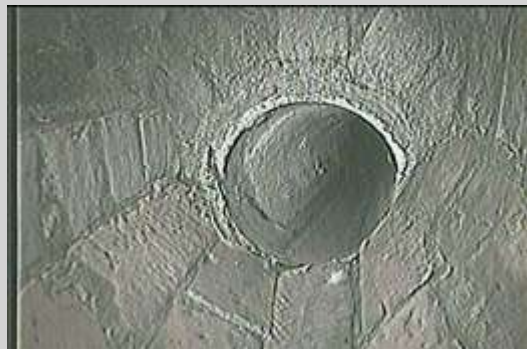
Pipe In @ 8 O'Clock

Infiltration: **Evidence**

Pipe Seal Cond: **Cracked**
